PHASE I INSPECTION REPORT

NATIONAL DAM INSPECTION PROGRAM

Broadford Run Dam, Little Youghio gheny River Site
Number 6. (NDI I.D. Number MD-36 Ohio River Basin)

ACKENHEIL & ASSOCIATES, BALTIMORE, MD, INC.
7902 BELAIR ROAD
BALTIMORE, MARYLAND 21236

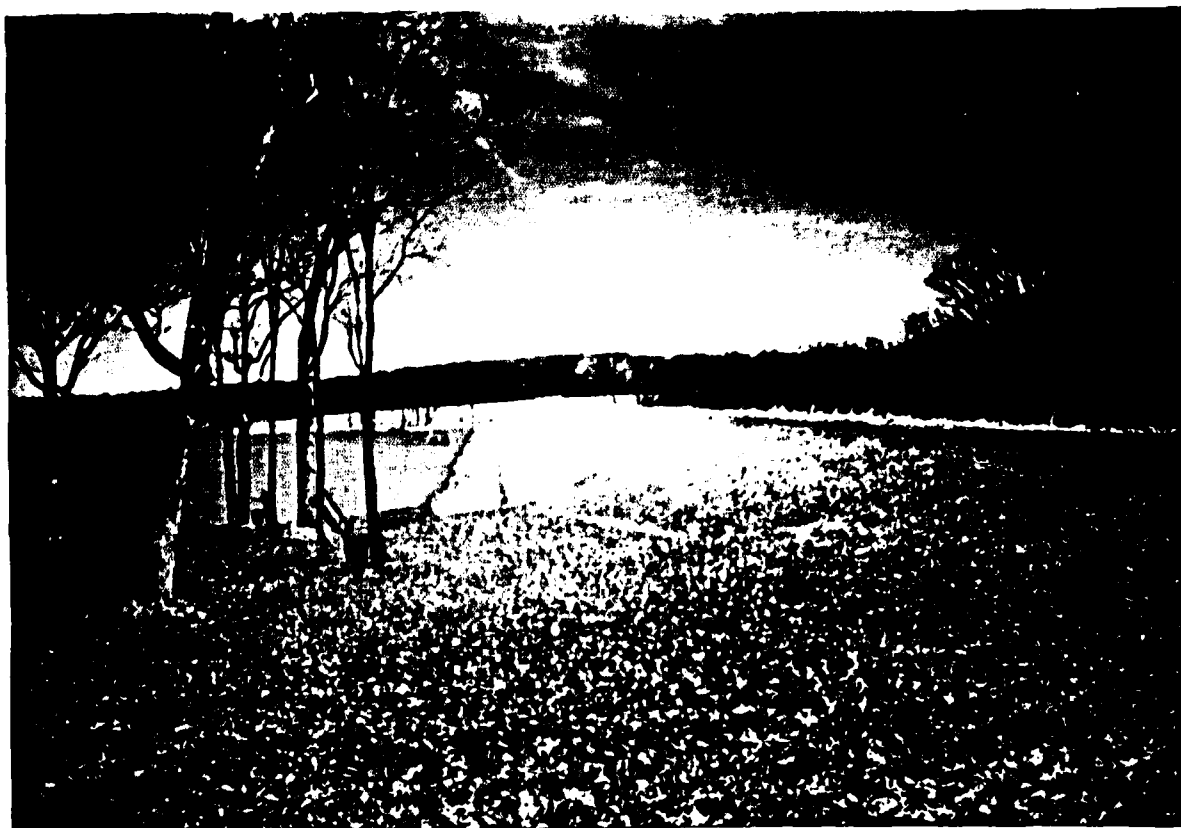
Overview of Dam
